**State of Louisiana
Department of Natural Resources
Coastal Restoration Division and
Coastal Engineering Division**

**2005 Operations, Maintenance,
and Monitoring Report**

Lake Portage Land Bridge

State Project Number TV-17
Priority Project List 8

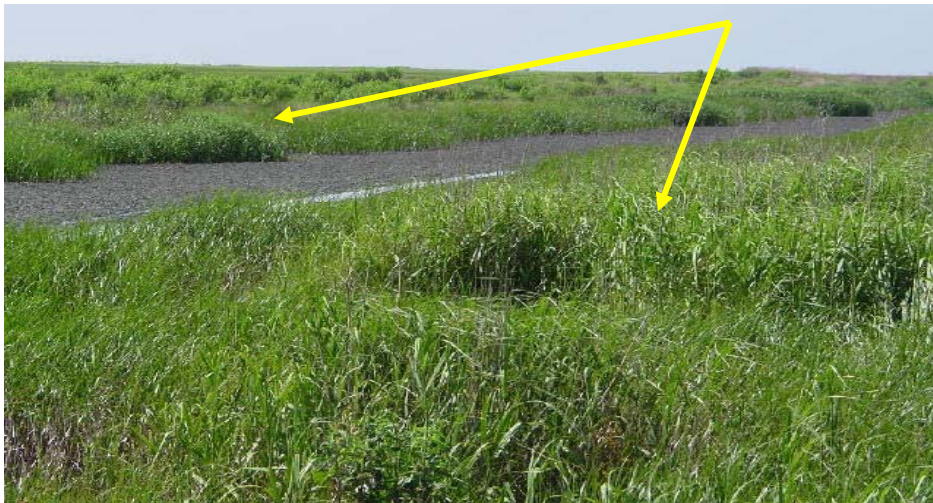
“At Site 1, located immediately south of the bulkhead, the bare portion of the created area was found to be smaller, that is, more narrow than it appears to be in the April aerial photos. New, robust vegetative growth is encroaching inward from both sides of the old canal spoilbanks. The composition of the newly vegetated area was almost 100% *Schoenoplectus robustus*, formerly *Scirpus robustus* (leafy three-square), with a trace *Calystegia sepium* (hedge bindweed). The vegetative community on the adjacent spoilbank was co-dominated by *Phragmites australis* (roseau) and *Spartina cynosuroides* (big cordgrass), with *Cynodon dactylon* (Bermudagrass) and *Baccharis halimifolia* (eastern baccharis) also occurring along with traces of *Spartina patens* (marshhay cordgrass), *Schoenoplectus americanus* (olney three-square), *Sesbania* sp., *Solidago* sp., *Ambrosia artemisiifolia* (ragweed) and *Ranunculus muricatus* (spiny buttercup). The yellow arrows in the photo below indicate the vegetative community colonizing the lateral edges of the created area at Site 1.”

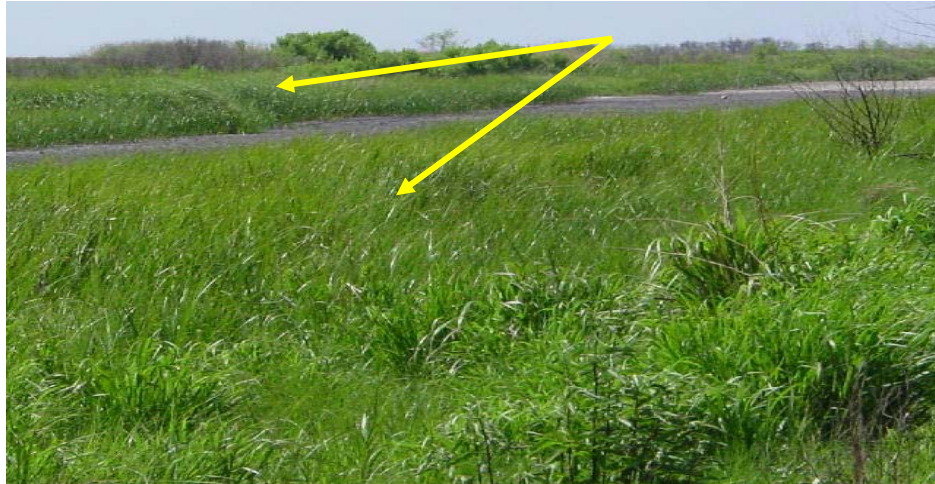
“Site 2 is located approximately halfway between Lake Portage and the old existing plug to the south. The conditions here are similar to Site 1, although, the newly developing vegetative community covers a larger percentage of the created area, and is slightly more diverse with leafy three-square as the dominant species, and marshhay cordgrass and *Spartina alterniflora* (smooth cordgrass) co-dominant. *Distichlis spicata* (saltgrass), morning glory, *Iva frutescens* (big leaf sumpweed), eastern baccharis, and *Amaranthus* sp. also occurred in small to trace amounts (see figure below). The deposited sediments were not trafficable yet at Sites 1 or 2.”

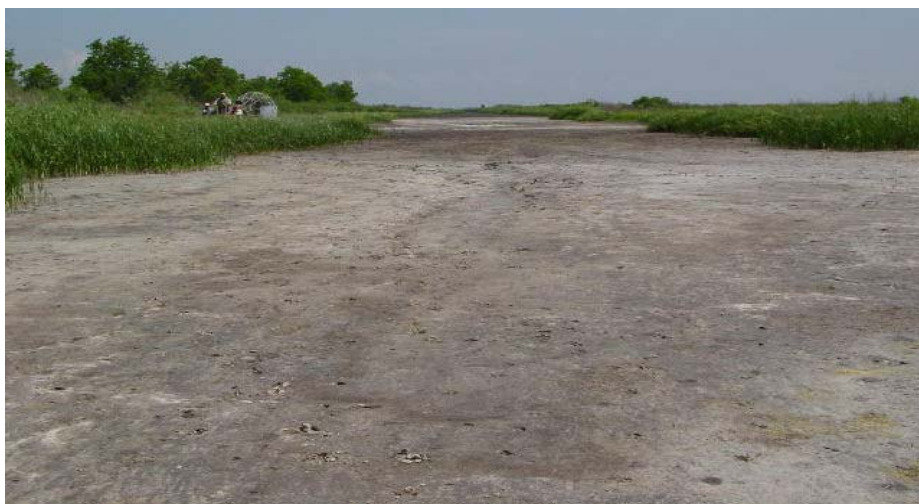
“Site 3 is located immediately north of the old plug. This area has the largest percentage of unvegetated area of all the sites visited, but natural colonization has begun at the edges.”

“This site is easily trafficable. The elevation is slightly higher and there appears to be a higher sand component in the deposited material than at the other sites, and therefore, is somewhat drier. That may explain why initial establishment of vegetation at this site has occurred more slowly.”

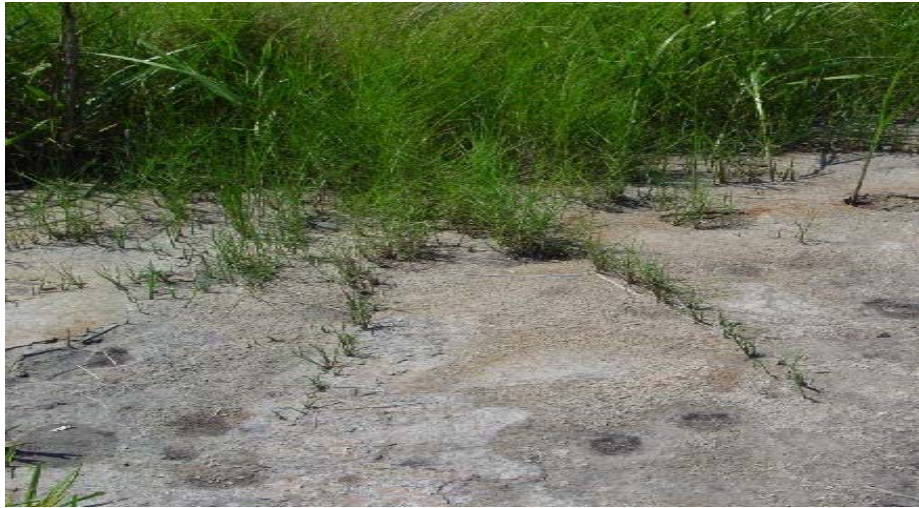
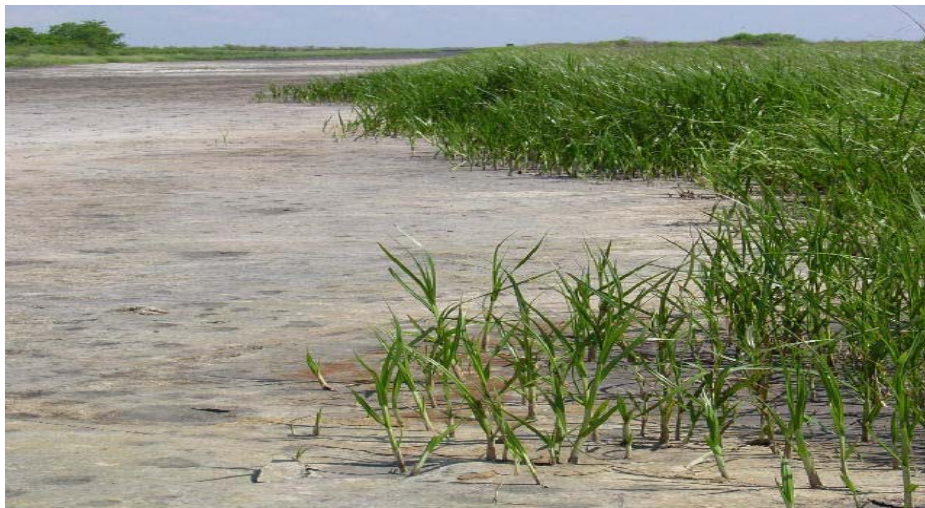
“Leafy three-square composes approximately 50% of the new vegetative community along the very edge of the created area, with marshhay cordgrass, salt grass, big cordgrass, and smooth cordgrass composing the remainder. However, evidence suggests that vegetative encroachment onto the created area is accelerating. New shoots and stolons were observed encroaching onto bare areas all along the newly-established edge community, as shown in the two pictures below.”

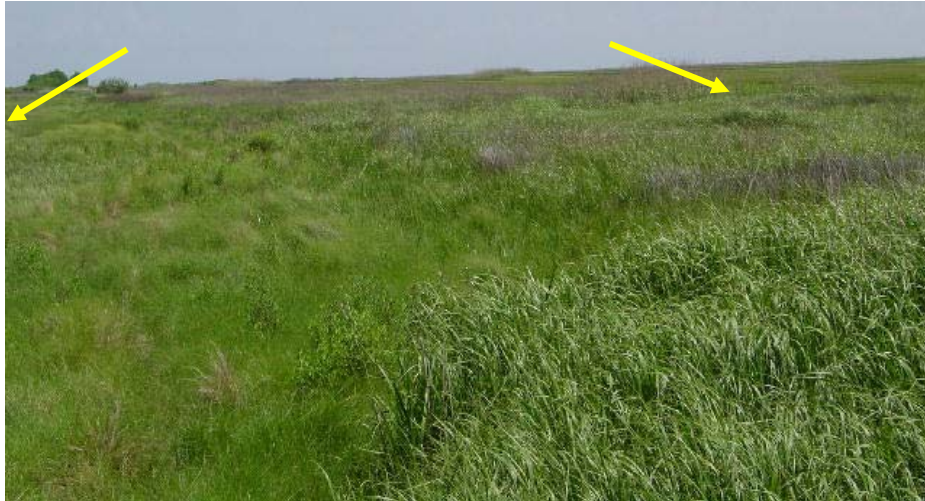
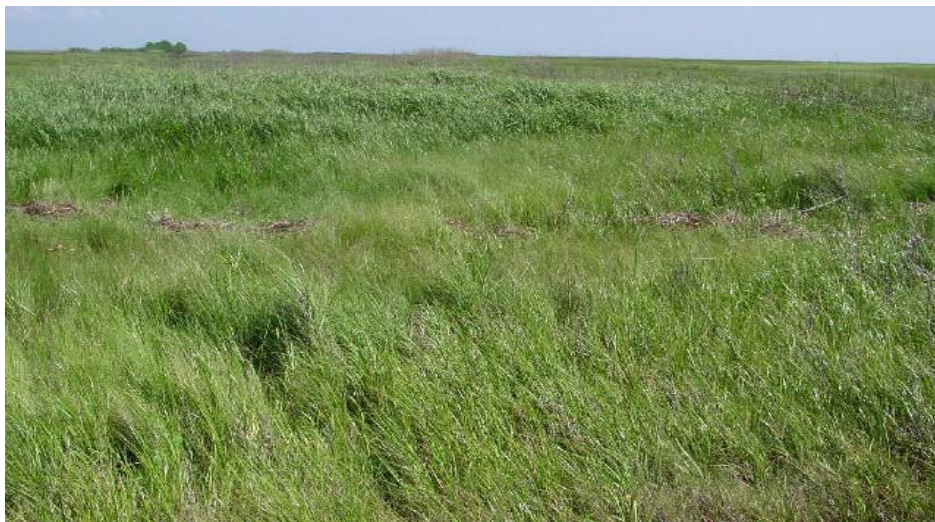
“Site 4, located on the created area immediately north of the gulf, is shown in the following two pictures. Yellow arrows point to the old canal spoilbanks.”

“Vegetation has colonized this site completely. Here, leafy three-square and smooth cordgrass were found to be the dominant species, with marshhay cordgrass, and big cordgrass co-dominant. Roseau and eastern baccharis also occur in small amounts.”

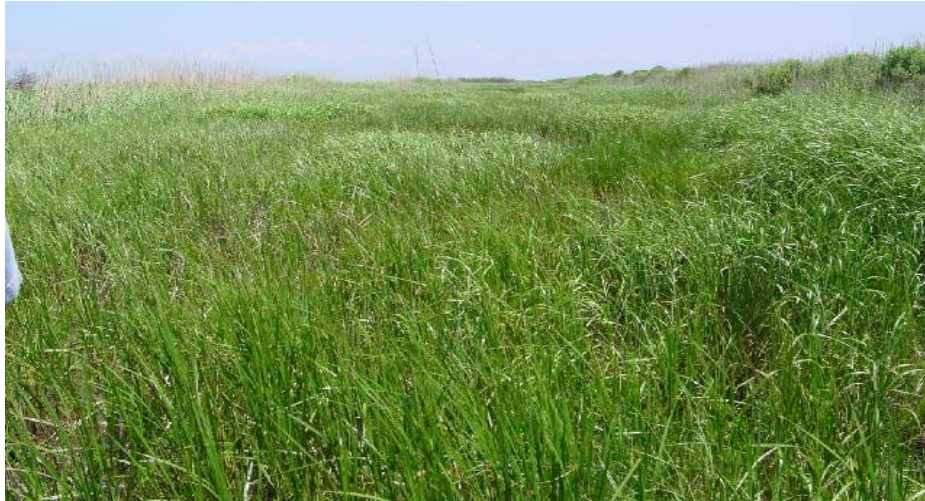
“Site 5 is located on the northern unit of the created area, immediately north of Lake Portage. This site is also almost completely vegetated with a very robust community of smooth cordgrass, leafy three-square, and roseau, as seen in the photo below.”

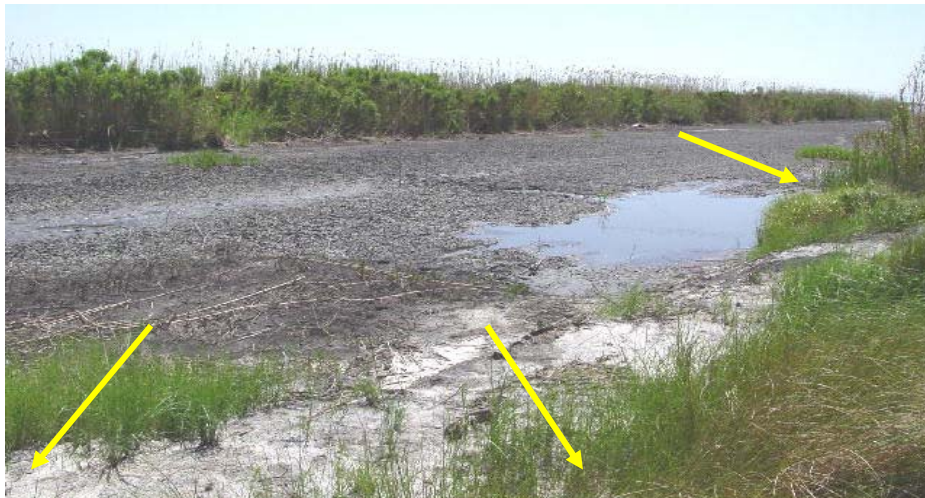
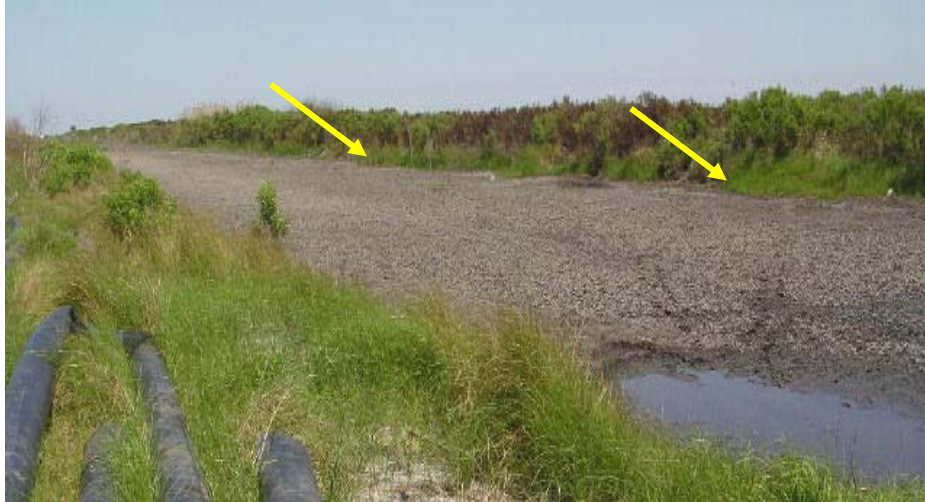
“Findings at this last site contrasted significantly with conditions found in the north unit of the created area at the same time in the previous year. The following pictures of the northern unit were taken in April 2004. Arrows indicate the small pockets of emerging vegetation just beginning to colonize the created area at that time.”

“Summary & Recommendations: As shown in the above pictures, less vegetation was found pioneering the created area in the northern unit at this time last year than that found along the edges of the bare area in the southern unit on the date of this field trip, and the northern unit is now totally vegetated. Using this progression of the plant community in the northern unit as a reference, it is reasonable to expect that the remaining bare areas in the south will be vegetated by the end of the growing season this year. A targeted planting with vegetative material would not likely achieve comparable results any sooner, especially given the time required for contracting and plant expansion. A temporary seeding application may achieve cover at a faster rate, but there is no seed for any brackish marsh species readily available, and as no significant erosion appears to be occurring, I do not recommend a critical area seeding application to address the bare areas that remain.”

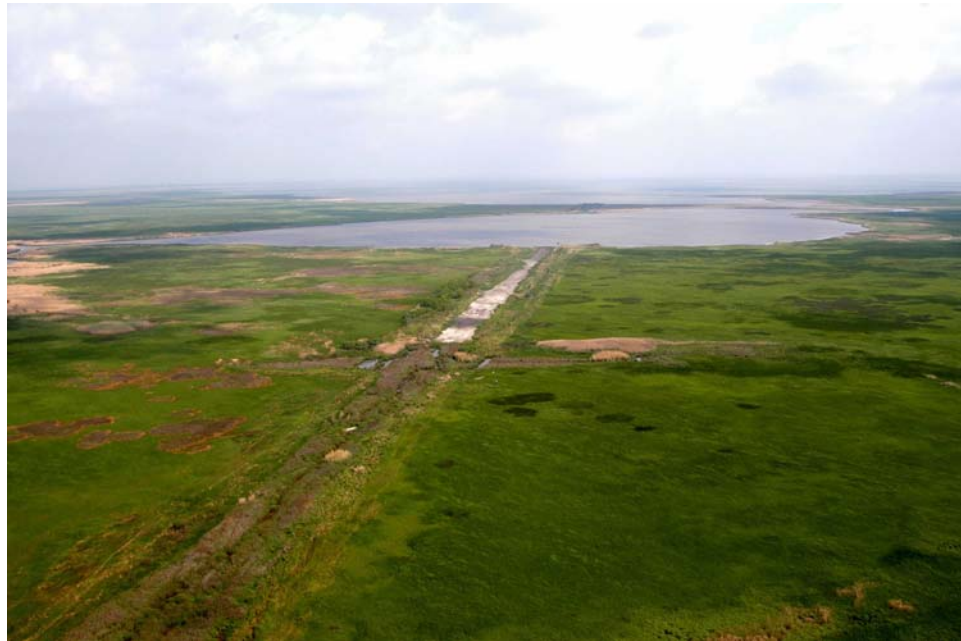
Photo 1- Aerial view of Areas 1 & 2, Flown by LDWF, April 2005 (looking north)

Area 1 is in good condition and is showing signs of vegetation starting along the containment banks moving towards the center of the channel. Recent aerial photographs taken by LDWF show increased vegetation growth within the last month, which should continue with warmer temperatures into the next few months. The center part of the filled-in channel was dry and hard enough to walk across in some areas. As a result of the inspection of Area 1, LDNR and NRCS agree that no corrective actions will be required this year. (Photos: Appendix A, Photos 1 & 3).

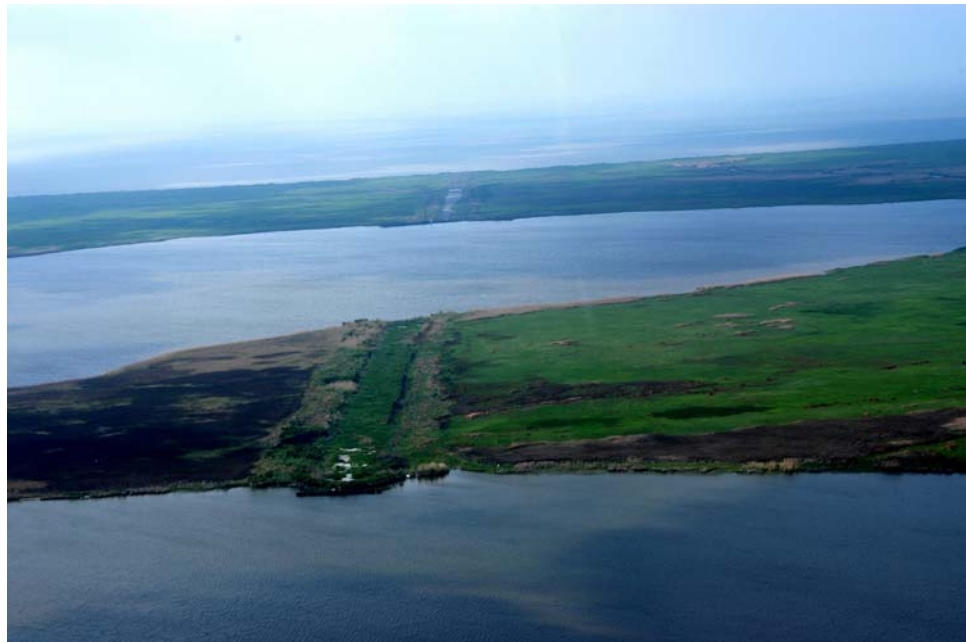
Photo 2- Aerial view of Area 3, Flown by LDWF, April 2005 (looking south)

Area 3 also is in good condition. The northern part of this reach is fully vegetated, mainly due to the fact that this reach was constructed first, and has been in place since May 2003. The water level at the southern end of this area was estimated to be +1.5 ft based on the level of the water at the weir notch on the 15-in.(38-cm) drain pipe. LDNR and NRCS agree that this area is in good condition and no maintenance will be required at this time. (Photos: Appendix A, Photos 2, 5 & 6).

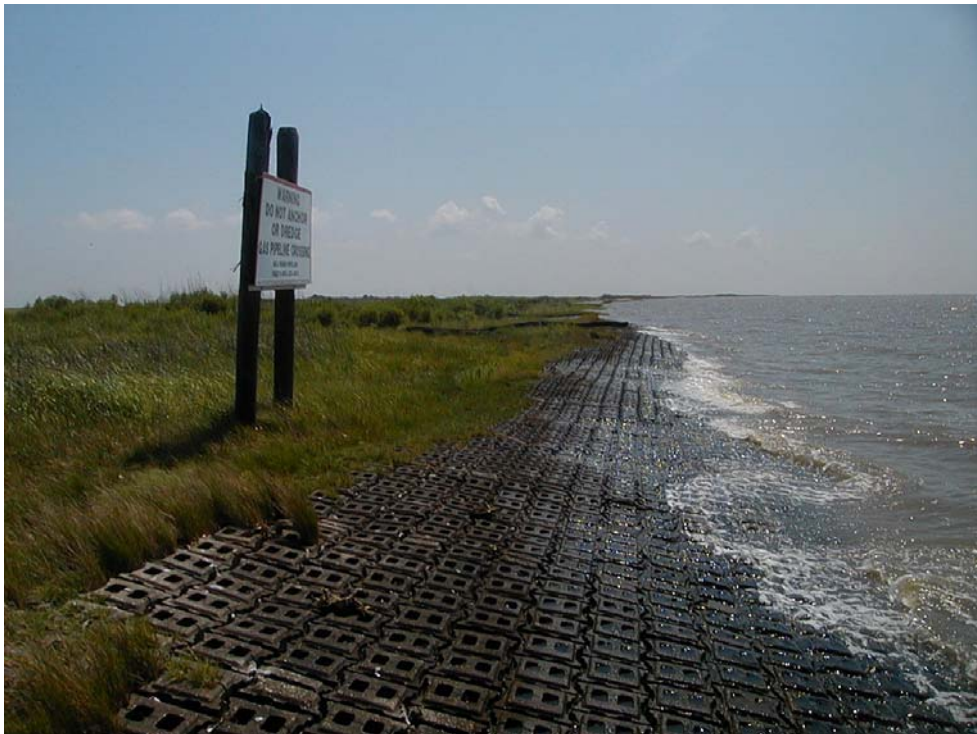
Photo 4—Area 2, revetment on gulf shoreline (looking east)

Area 2 is also in good condition and is fully vegetated. This reach was previously filled and the Lake Portage Land Bridge project added additional dredge material to fill in any trenasses. LDNR and NRCS agree that no maintenance will be required at this time. (Photos: Appendix A, Photo 4).
